ADVISORY BULLETIN

NUMBER 4	ISSUED 15/12/18	VERSION 1.0	PAGE 1 OF 1
--------------------	---------------------------	-----------------------	------------------------------

Crown shock

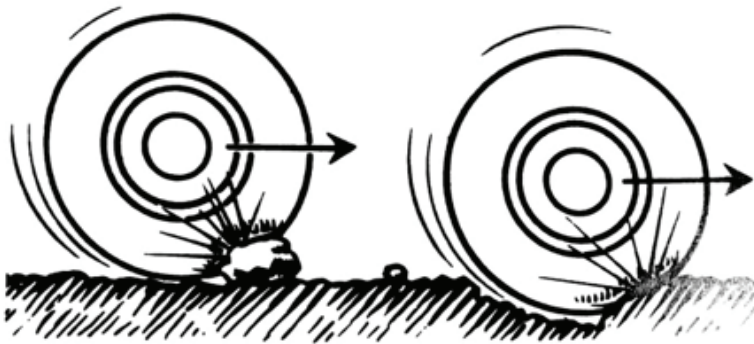
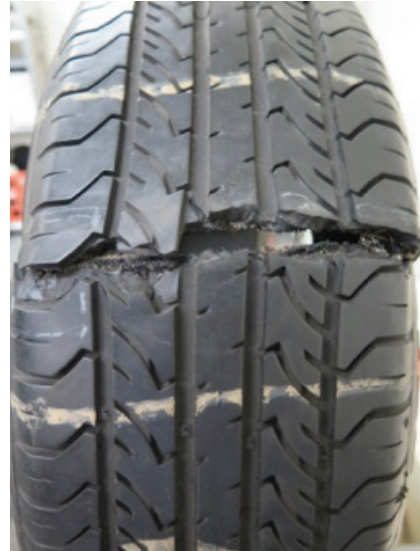
Accidental damage causing total rupture, and pressure loss, through the crown plies. Break is clean with no fraying of the cables.

Severe shock in the tread such as impact, cut or puncture. Inspect rim for marks and abrasion to the flange. Internal damage can progress with further use and eventually cause internal tyre detachment or sudden loss of inflation.

Due to the force of the impact the crown components (tread rubber, casing, crown plies) have been weakened and or broken. Impact damage to the tyre may initially show little or no exterior evidence.

Adapt driving to road conditions. Avoid obstacles or debris on the road.

Regardless of the actual cause, keeping such a tyre in service is dangerous. The tyre must be demounted immediately and scrapped.
